Equipment details

Customer: IMC Diving AS
 Producer: Kirby Morgan
 Serial no: 15078SS
 Service interval: 12 months

Location: 138
 Model: 97
 Build year:

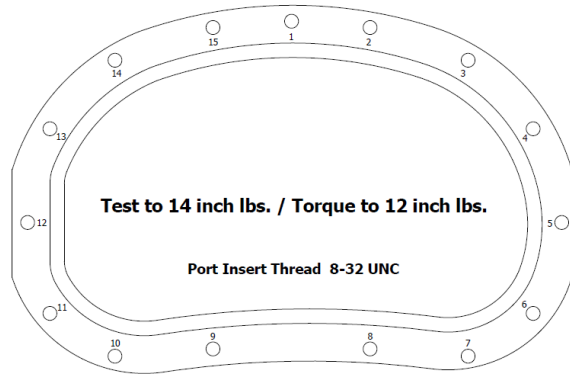
Port Insert Test Sheet (A2.1)

Port insert 1	Pass	Port insert 9	Pass
Port insert 2	Pass	Port insert 10	Pass
Port insert 3	Pass	Port insert 11	Pass
Port insert 4	Pass	Port insert 12	Pass
Port insert 5	Pass	Port insert 13	Pass
Port insert 6	Pass	Port insert 14	Pass
Port insert 7	Pass	Port insert 15	Pass
Port insert 8	Pass
